Silicon Precipitate Nodule-Induced Failures of MOSFETs

M. Johnson and D. Pote
Motorola, Inc.
Northbrook, IL

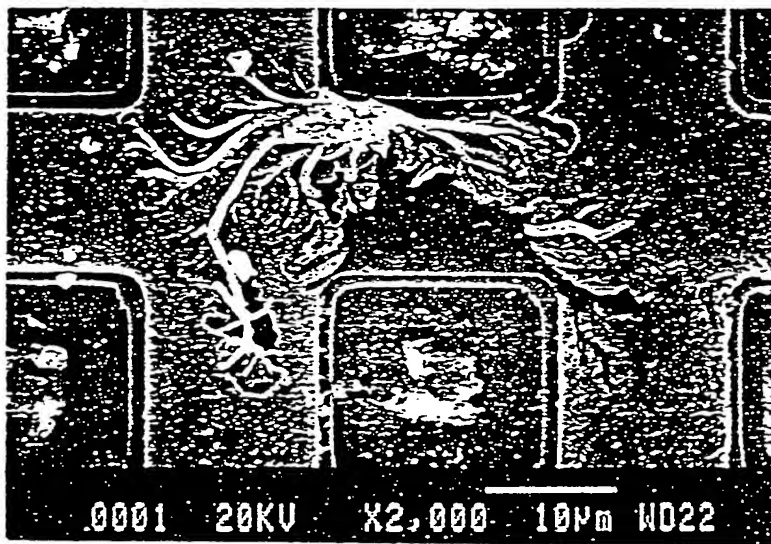
Figure 1: Unique pattern of fused polysilicon observed after removal of metallization and insulating oxide. (2000X)

Subsequent optical inspection identified an apparent electrical damage site under the wirebond. This damage was characterized by a central fused-site surrounded by multiple filaments (Figure 1). These filaments were dubbed "tentacles" or "roadkill" damage because of their appearance. SEM inspection of the same locations revealed surprisingly little

It is now believed that the filaments are the result of amplification of the damage at the original failure sites by the application of excess power during liquid crystal testing. A slightly higher level of power was necessary to counteract the obstructing heatsink effect of the relatively large wirebond. The heat generated at the damage site would initiate crystallization of the amorphous polysilicon depend-

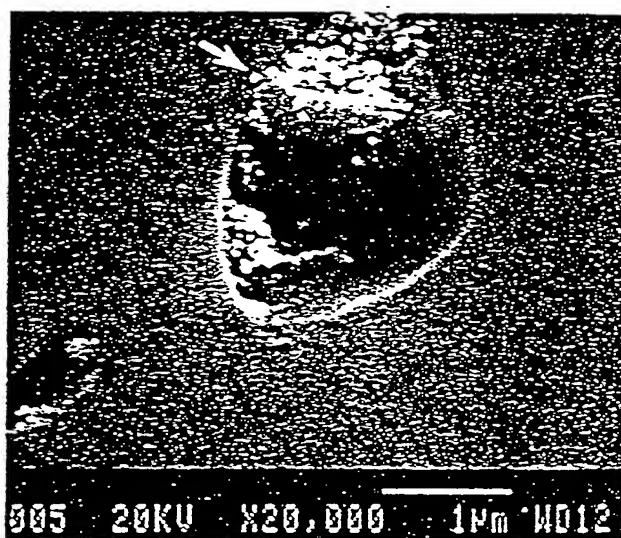
Figure 2: Small electrical damage site within chipet.
(25000X)

Cross-sections of failures revealed that the filaments were confined to the polysilicon layer, except at the central nucleus. At the nucleus, melted silicon and aluminum were observed extending vertically through the dielectric layer. On several devices where the filamentation was minimal, there was limited evidence of melting at the nucleus site and a small section or chip of the dielectric was missing (figure 2).

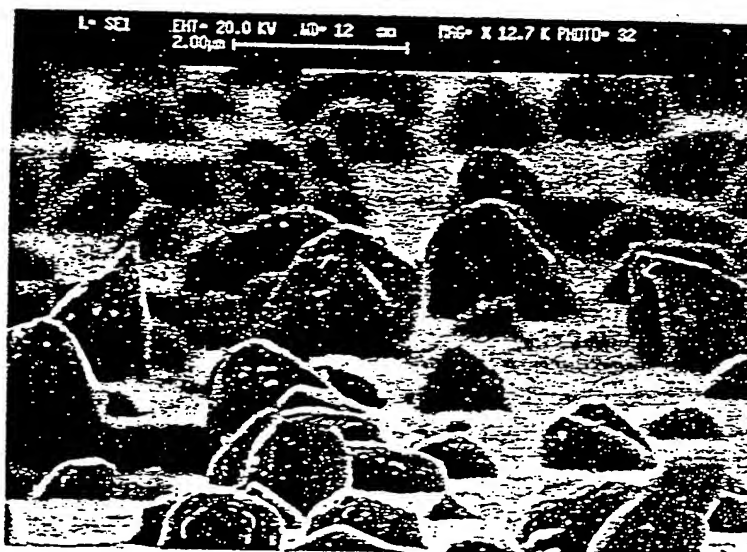
shape. Although they appear roughly circular under high power microscopy (400X), they are actually polyhedral and exhibit a wide range of aspect ratios (Figure 3). Typical height/width ratios range from 0.3 to 1.8.

Figure 3: Silicon precipitates (nodules) viewed from side exhibit variety of shapes and sizes. (12700X)

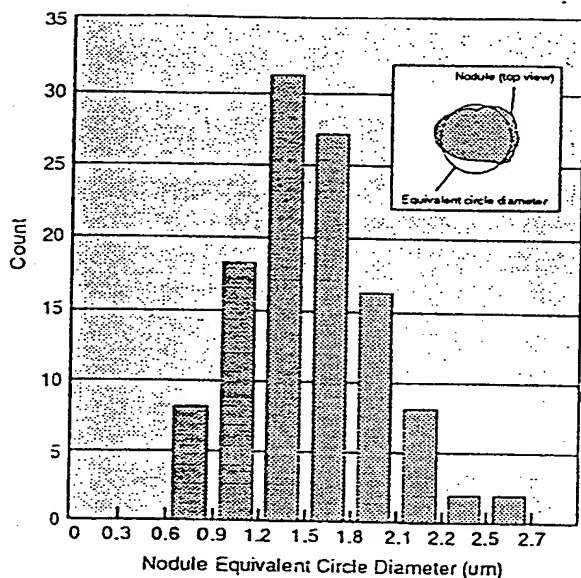
There were typically 50×10^3 to 100×10^3 nodules per square millimeter in the subject devices. In general, the nodule density -- the number of nodules per unit surface area -- was inversely proportionate to the average size of the nodules. That is, when the nodules were large, there tended to be few of them. Conversely, when the nodule count was high, they tended to be small. Figure 4 shows a typical histogram of nodule sizes produced by an image analysis

Figure 4: Example distribution of nodule sizes

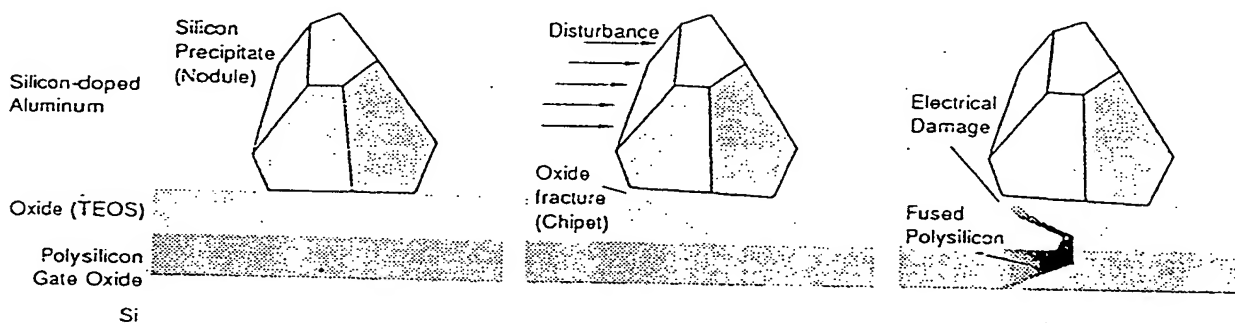
The adhered nodules could be removed quite easily; gentle brushing of a few fibers from a cotton swab was sufficient to disturb them. When these well-adhered nodules are displaced, they often take with them a portion of underlying oxide, forming a distinctive, football-shaped chip-out, or *chipet* (Figure 5). The depth of the resulting chipet was roughly equal to half the length of the chipet's minor axis, itself related to the area of contact between nodule and oxide.

In the MOSFET devices the lateral displacement of the nodules occurs during the wirebonding process. The cavity formed by the chipet is immediately filled with aluminum. These chipets, during

Figure 5: Movement of nodule results in fracture of underlying oxide.

electrical stress, appear to act as weak points in the insulating oxide. If the chiplet is sufficiently deep to fully compromise the thickness of the dielectric oxide, a linear resistive short between the source metallization and gate polysilicon results. However, if the root only partially compromises the dielectric, a leaky diode-like characteristic results.
